Inspection Report

Report #: 111111

Company Information:
Dahl Home Inspections, LLC

Date:
4/13/2018

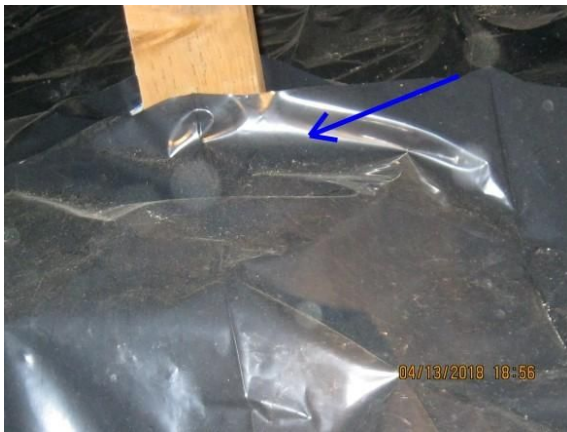
1. Repair :-> The vapor barrier was wrapped around concrete piers in west side of crawl. Recommend cutting and removing so as not to trap moisture at base of posts.

- **Crawl Space:** The vapor barrier was wrapped around concrete piers in west side of crawl. Recommend cutting and removing so as not to trap moisture at base of posts.

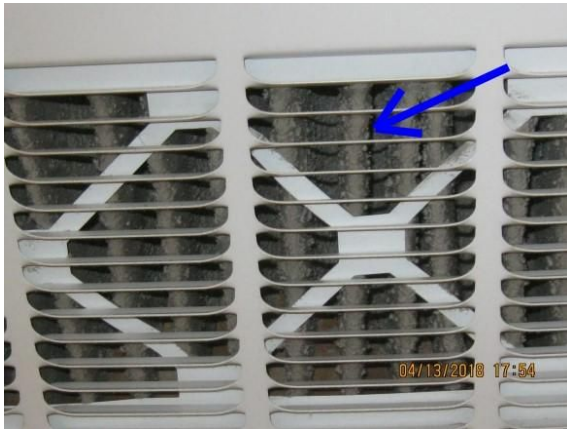
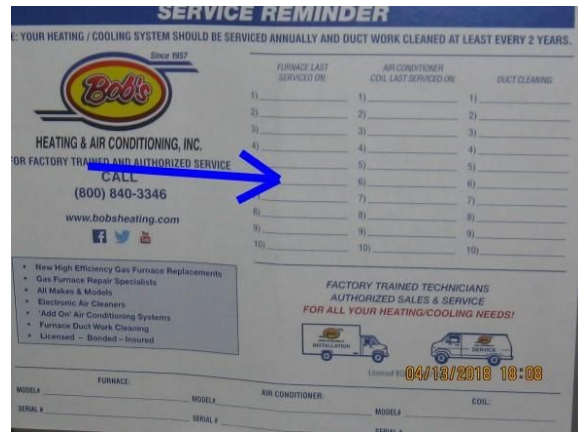
3. Repair :-> Furnace filter is dirty and needs replacement. There was no record of service of furnace since installation. Recommend licensed HVAC service of furnace and its attached venting system.

- **Heating, Cooling and Fireplaces:** Furnace filter is dirty and needs replacement. There was no record of service of furnace since installation. Recommend licensed HVAC service of furnace and its attached venting system.

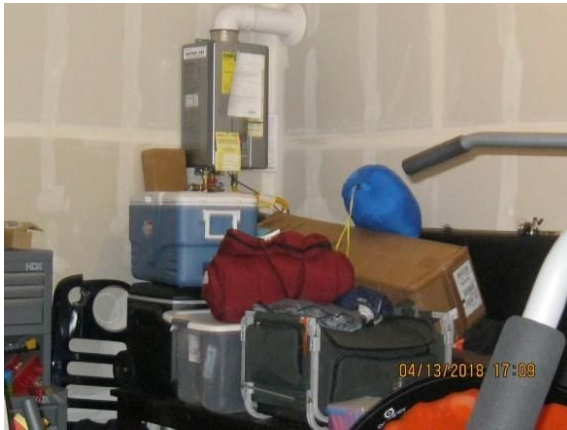
4. Note :-> Believe the main water shut-off is possibly in garage but could not verify due to personal storage items blocking view.

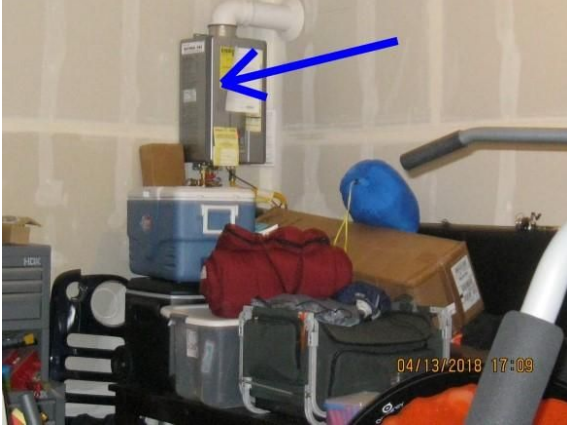
5. Note :-> Personal storage items blocked access to tank-less hot water heater.

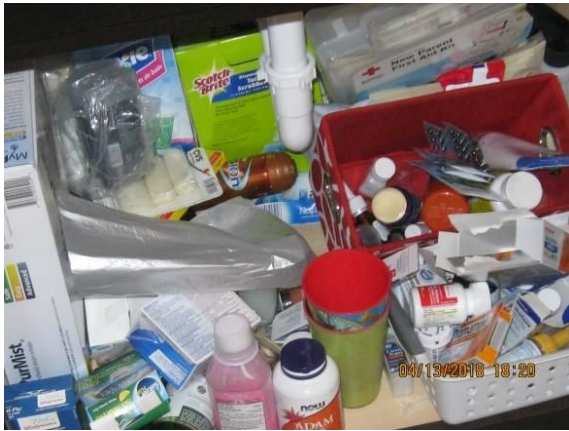
6. **Note** :-> Personal storage items limited inspection under sinks.

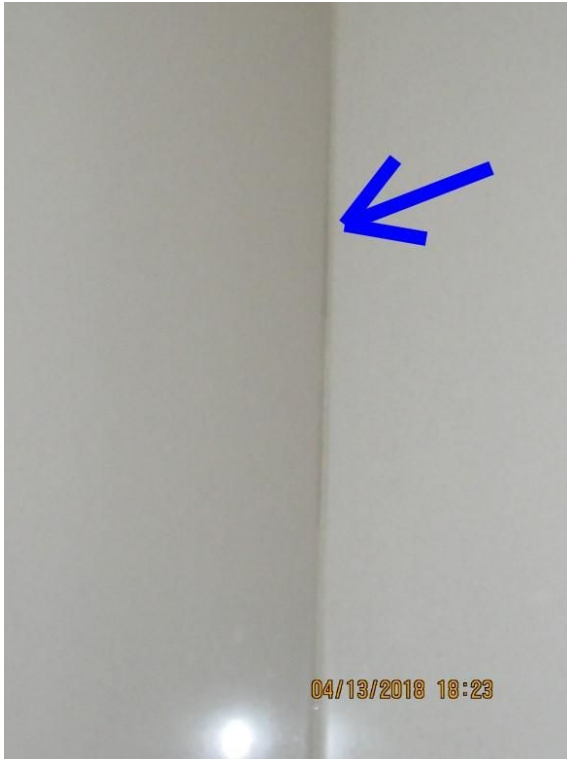
7. **Repair** :-> Recommend that master shower inside tile joint be caulked with a silicone caulk. Presently only a 'color caulk' is applied. . Also recommend sealing tile grout.

- **Bathroom(s):** Recommend caulking the master shower inside tile joint with silicone caulking. Presently only a 'color caulk' is applied. . Also recommend sealing tile grout.

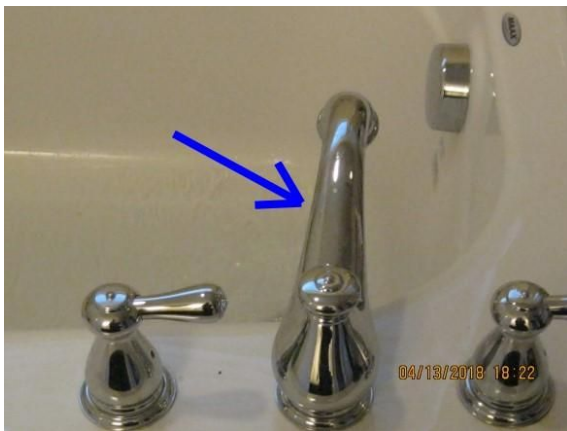
8. Repair :-> Recommend a qualified contractor tighten the master bath tub spout which is loose.

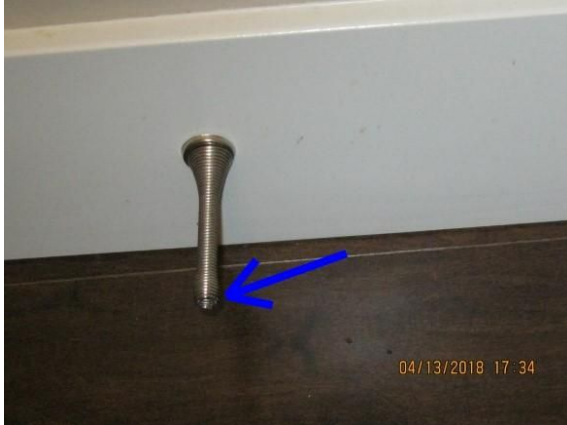
9. Repair :-> Minor repair at powder room door bumper. Missing rubber/plastic end.

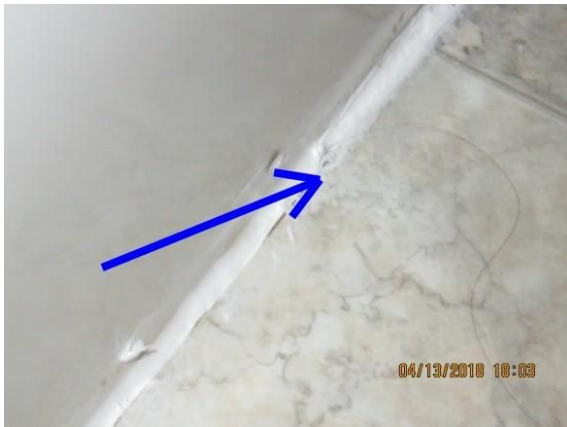
10. Repair :-> Recommend re-caulking at hall bath vinyl floor/tub area.

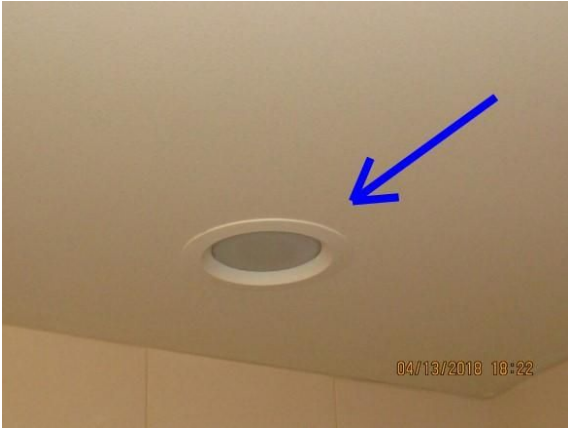
11. Repair :-> The light above master shower was not working-likely bulb replacement needed.

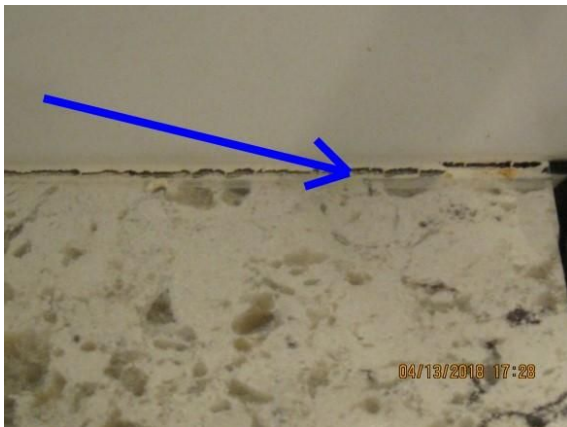
12. Repair -> Recommend re-caulking area along counter/backsplash in kitchen.

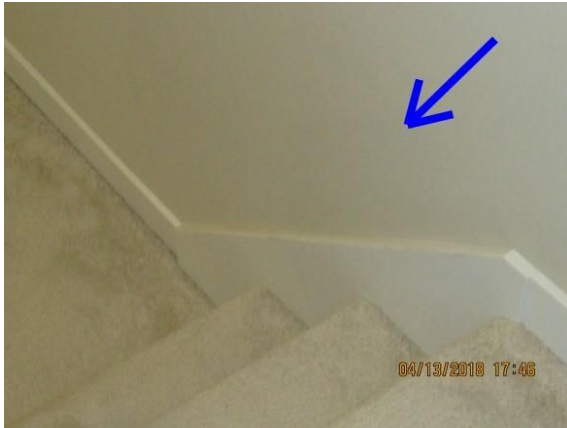
13. Improvement Item :-> Though not required due to the limited steps, a handrail installed at top of stairs could provide added safety.

- **Interior:** Though not required due to the limited steps, a handrail installed at top of stairs could provide added safety.

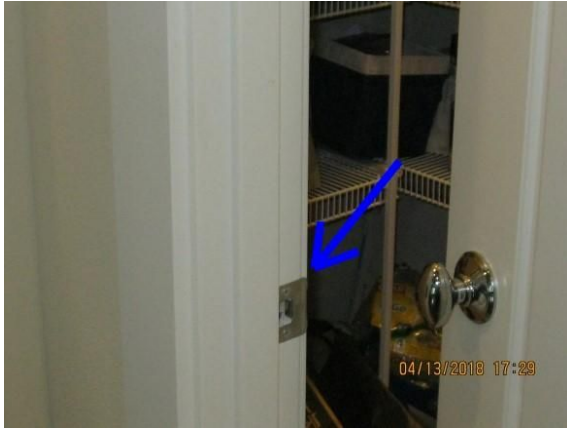
14. Repair :-> Recommend that the pantry door latch be adjusted for closure/latching. Check others and adjust as needed.

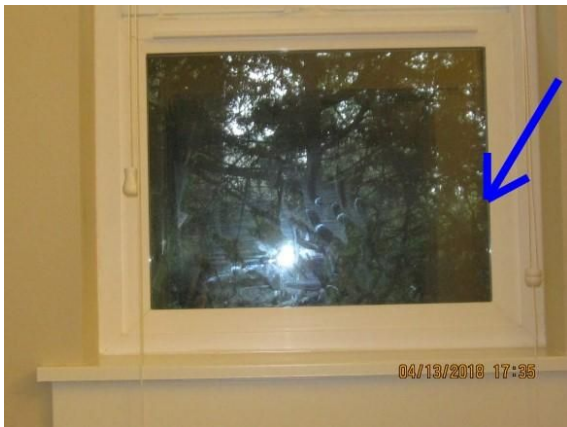
15. Repair :-> The single hung window in powder room doesn't open properly. Recommend re-setting the 'channel balance' hardware to restore window operation.

- **Interior:** The single hung window in powder room doesn't open properly. Recommend re-setting the 'channel balance' hardware to restore window operation.

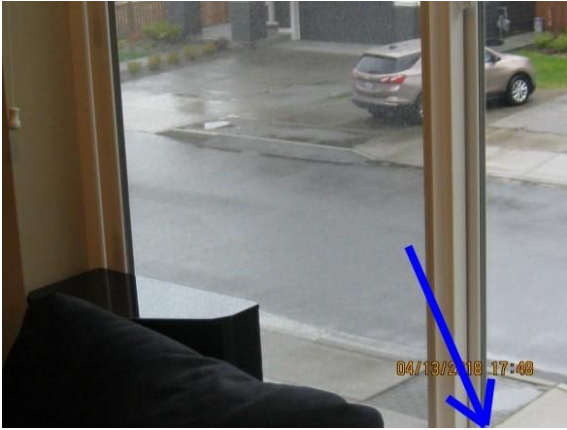
16. Repair :-> The sliding windows in the bonus/entertainment room are hard to operate and close. This observation was noted elsewhere as well. Recommend adjusting, making sure the track trim is tapped down flush, and possibly spraying a silicone or 'Armorall' to restore easier operation.

- **Interior:** The sliding windows in the bonus/entertainment room are hard to operate and close. This observation was noted elsewhere as well. Recommend adjusting, making sure the track trim is tapped down flush, and possibly spraying a silicone or 'Armorall' to restore easier operation.

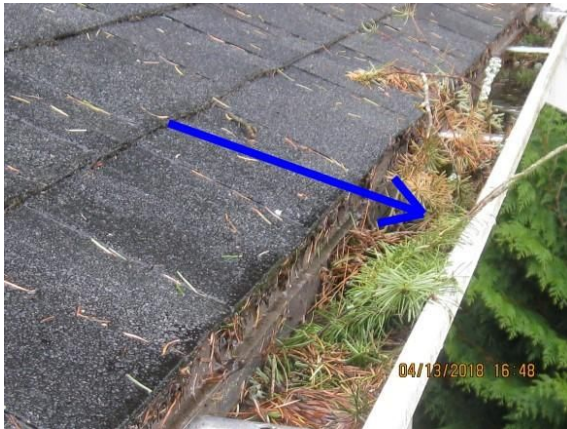
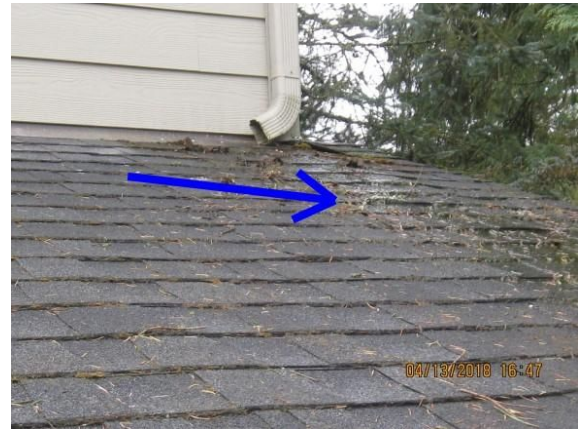
17. Repair -> The gutters are full of debris. Recommend gutter and roof cleaning of small branches.

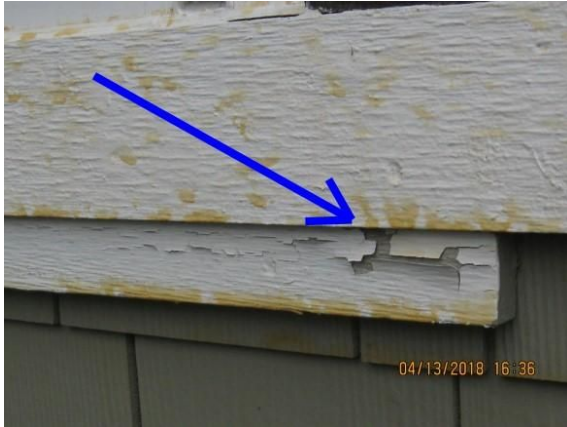
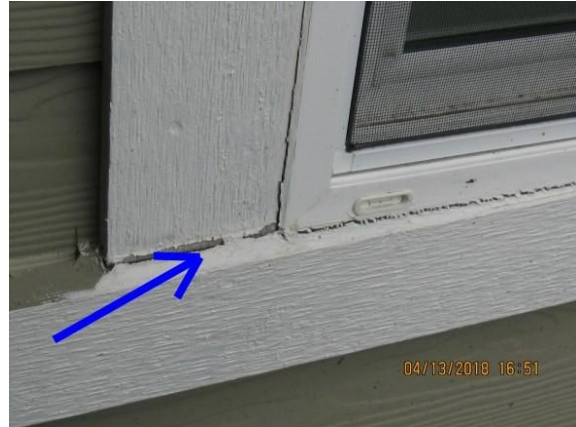
18. Repair :-> Recommend minor paint touch-up in front and back area trims

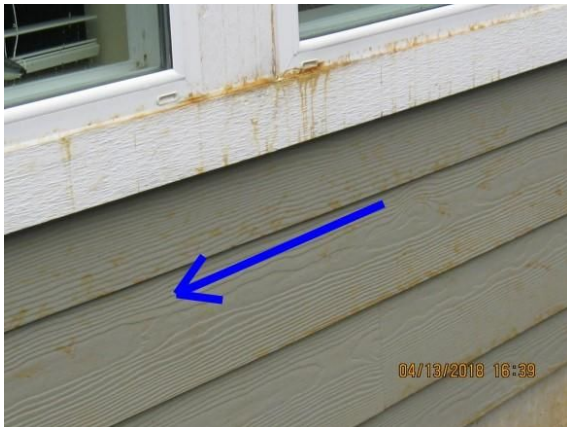
19. Repair :-> The siding has a lot of pollen residue. Recommend a careful pressure washing to remove.

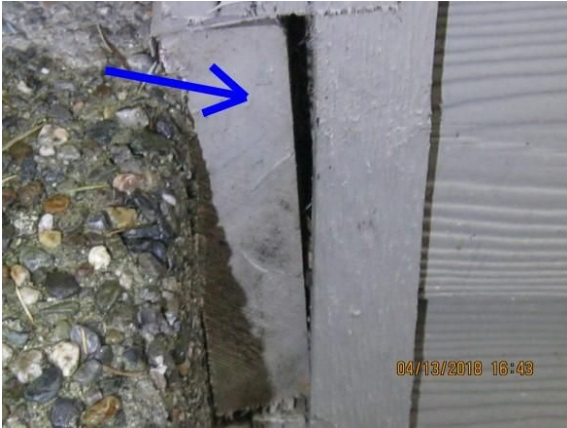
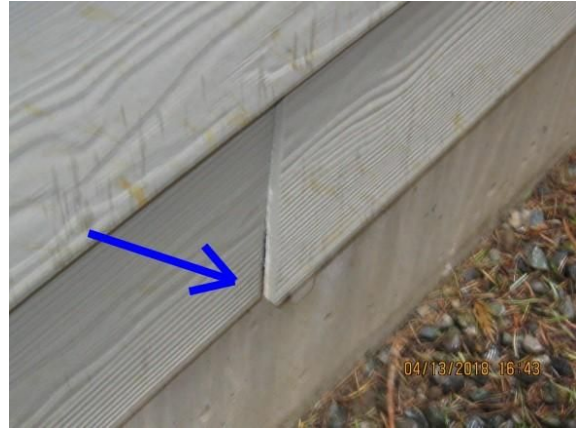
20. Repair :-> Recommend caulking open trim voids at back porch and where siding is separated on south side of house.

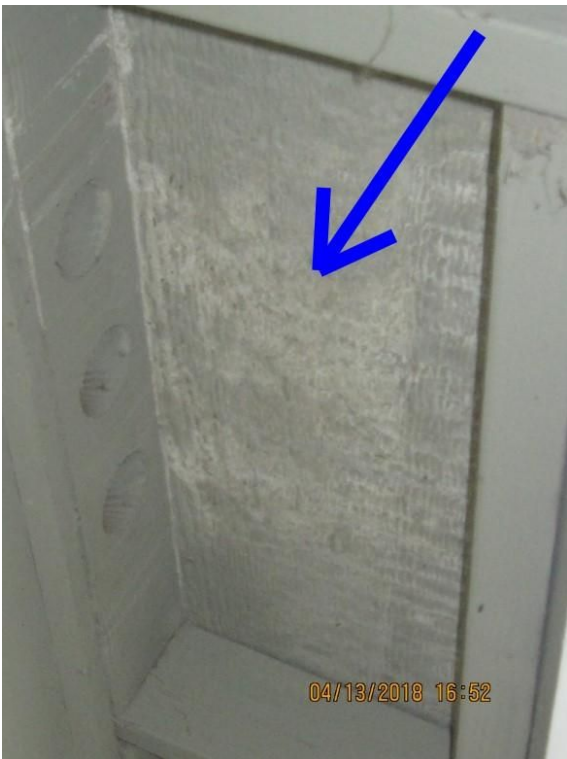
21. Repair -> Recommend paint touch-up of soffit. This location is above roof, over back patio on west side of house.

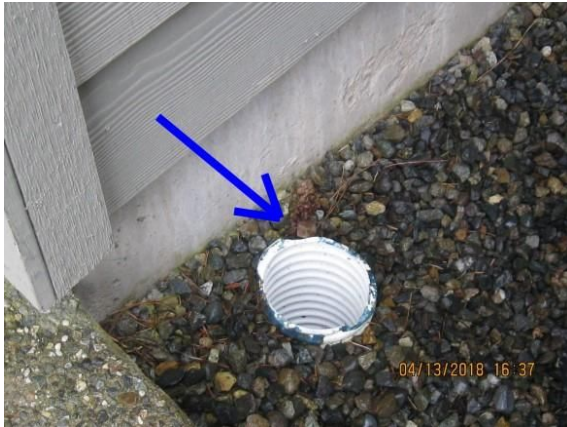
22. Repair :-> Recommend installation of a solid cover over abandoned downspout drain at NE corner of house.

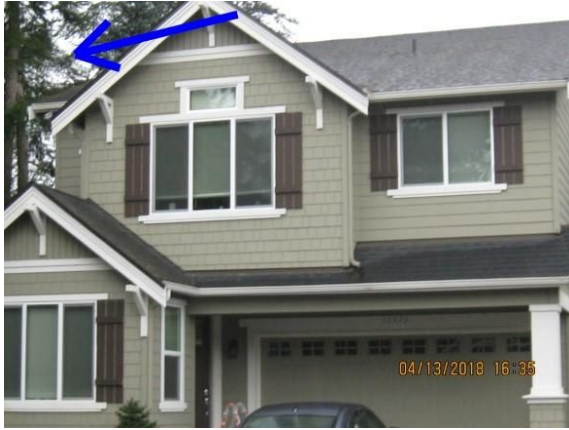
23. Monitoring Item :-> Large evergreens will shed needles and small branches. Recommend cleaning gutters twice a year.

- **Grounds:** Large evergreens will continue shed needles and small branches. Recommend cleaning gutters twice a year.
